STEEL-IT® Polyurethane Aerosol Perfect to Protect Brake Calipers

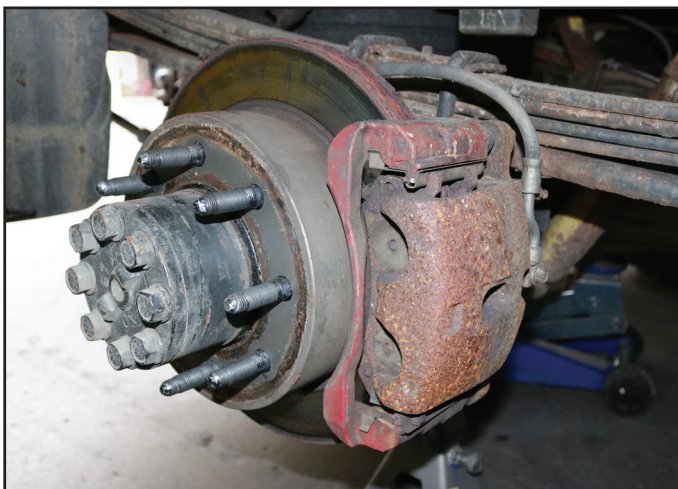
Caliper, after three years on the road, installed as purchased without any treatment

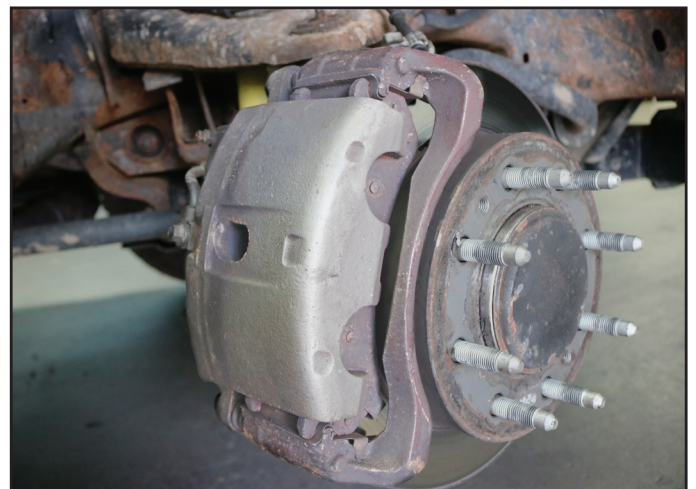
The same brand and part number of caliper as on the left, after the same three years, but sprayed with STEEL-IT Polyurethane Aerosol when installed
